LOST LAKE DAM
LINCOLN COUNTY, MISSOURI
MO. 10212

**PHASE I INSPECTION REPORT
NATIONAL DAM SAFETY PROGRAM**

SEPTEMBER 1979

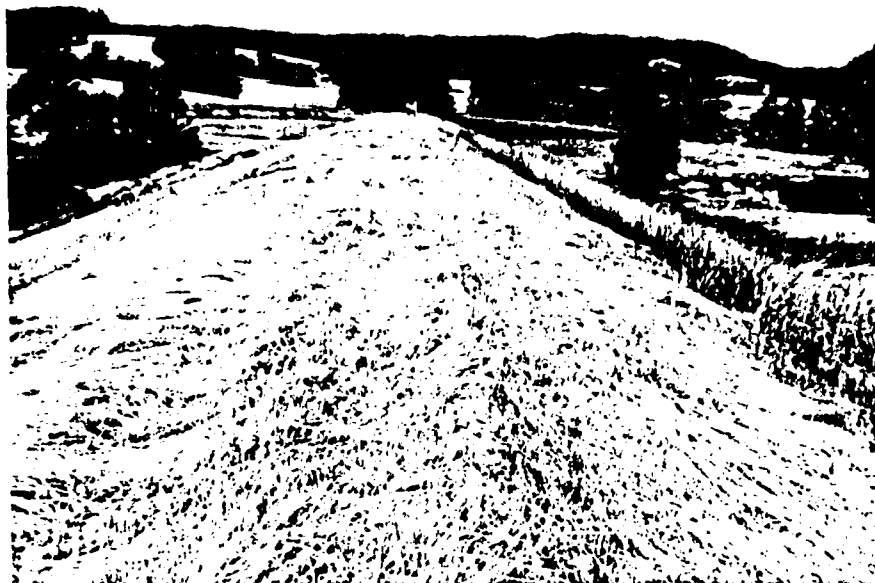
Photo 1

The crest of the dam is well protected against surface erosion by a well maintained cover of grass. There was no evidence of significant settlement or cracking on the crest. No significant deviations in horizontal or vertical alignment were apparent. According to Mr. Robert Glosier, the water level has never been higher than 8 feet up the slope above the principal spillway. Therefore, the emergency spillway has not been used and the dam has not been overtopped.

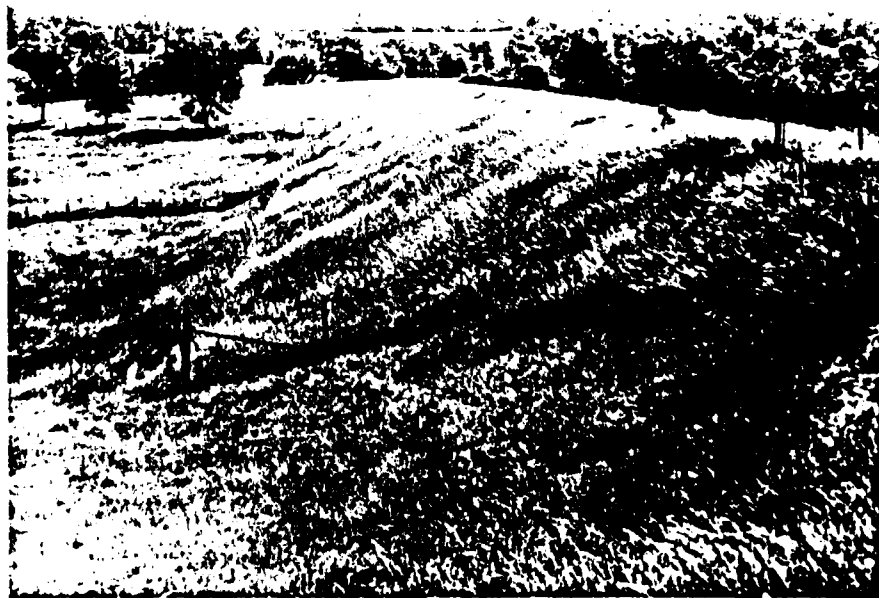
Photo 2

The downstream slope of the embankment has a heavy grass cover. According to Mr. Elmer Glosier, a slide on the slope occurred shortly after construction. The slide area is located on the upper half of the slope and immediately to the right of the principal spillway outlet. The damaged area was approximately 20 to 25 feet wide and did not extend to the crest. The slide was shallow in depth. Some minor erosion was observed on the downstream embankment near the fence on the left abutment. No other depressions, bulges or settlements were apparent on the downstream slope. No seepage was apparent along the toe of the slope. Materials removed

There were no signs of settlement or distress observed on the embankment or foundation during the visual inspection. The slide area on the downstream slope appears to be stable and is not serious enough to indicate an unsafe condition. According to Mr. Elmer Glosier, a professional engineer viewed the slide area shortly after the slide occurred. The professional engineer determined that the damaged area had no significant effect on the overall stability of the slope and that the slope had stabilized. According to Mr. Elmer Glosier, no other slides have occurred on the slope.

The slide area on the downstream embankment slope has stabilized and was determined by a professional engineer to pose no danger to the stability of the downstream slope. No other signs of distress were observed in the embankment or in the foundation, nor was seepage observed at any location. No seepage and stability analyses were available for review.
